# Helvetia Insurance Head Office

The west extension of the Helvetia Insurance building in St. Gallen is characterized by a cleverly coordinated irregularity, particularly in the form of differently inclined, storey-high window surfaces. The building thus blends smoothly into its surroundings.

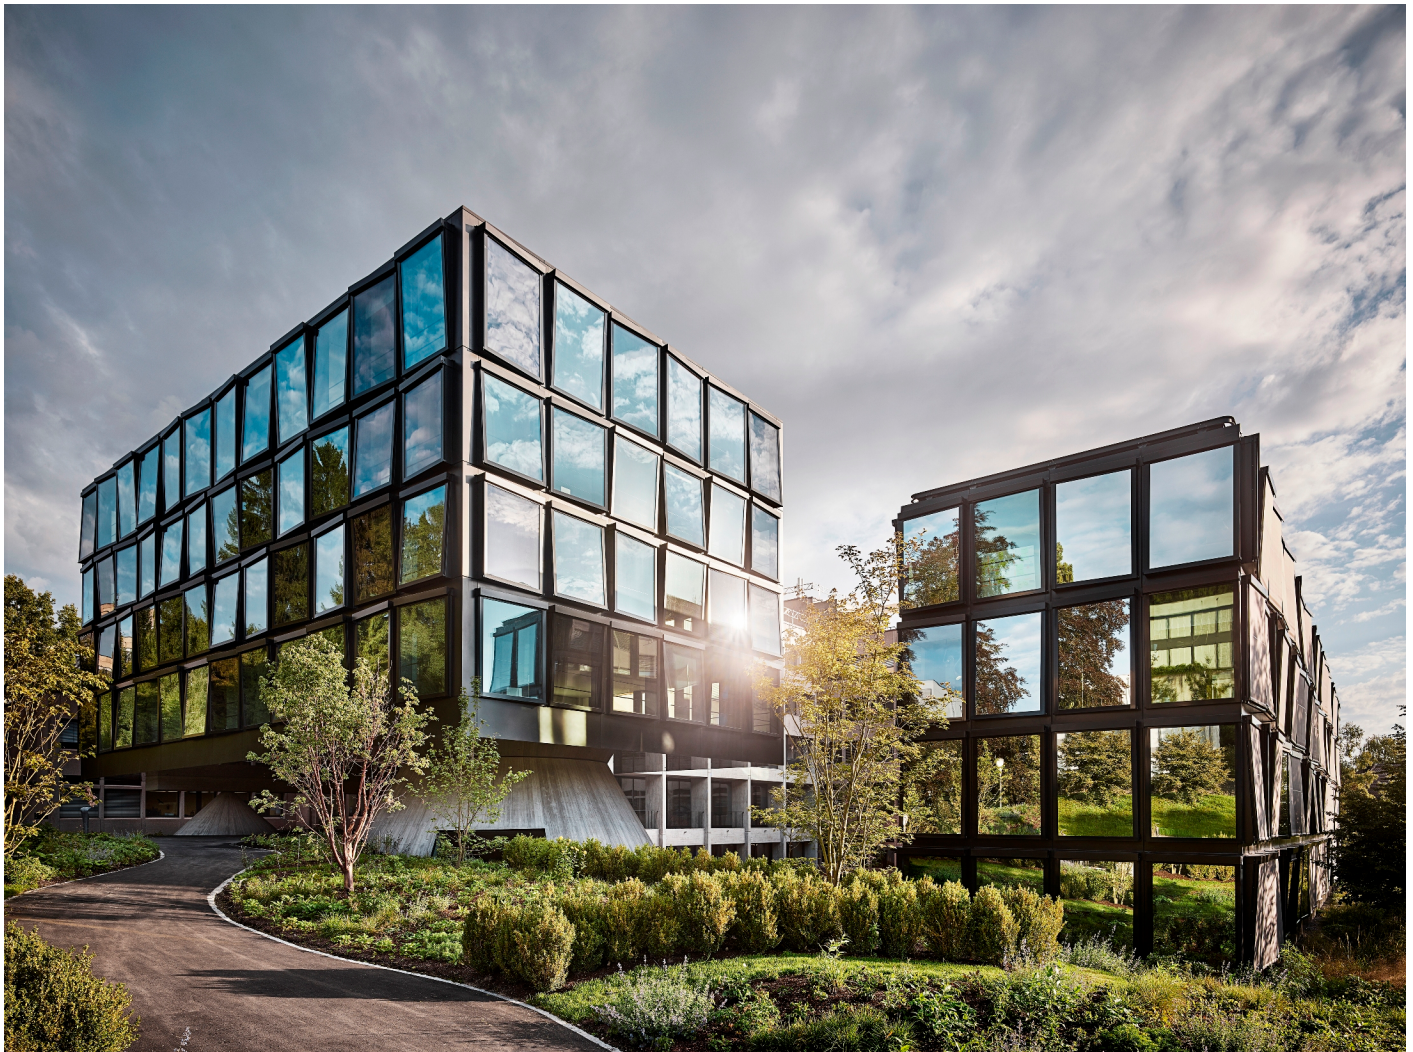
The newly constructed, block-like building extends the existing office complex to the west and is supported on two imposing concrete cones due to its hillside location. The unusual façade concept is dominated by floor-to-ceiling windows that project sculpturally from the façade plane at different angles. This artistic kaleidoscope reflects the surroundings in a sophisticated way - be it the sky, the garden or the immediate surroundings.

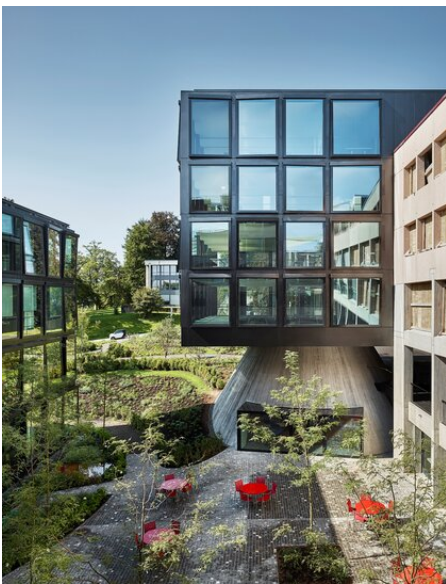
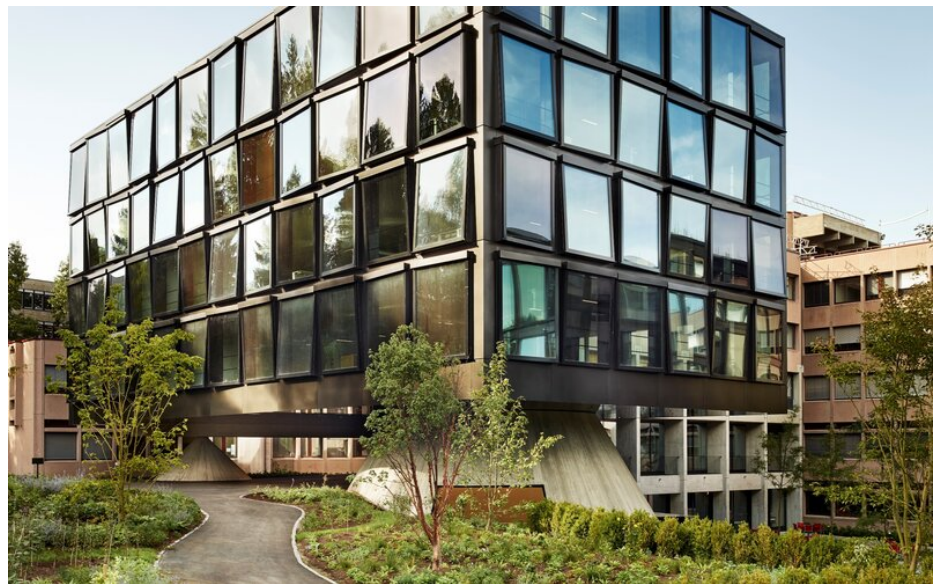
Another important element is the sun protection system, a special version of the 6011 façade awning from Kästli Storen, which was developed in collaboration with Herzog & de Meuron and the façade planner Emmer Pfenninger. The basic requirement was that the sun protection system should affect the unique façade concept as little as possible and ideally remain invisible. This was achieved by the almost seamless integration of the awning cassette into the framed window element, each of which protrudes to different heights.
